WATER PUMP NOT WORKING

Troubleshooting

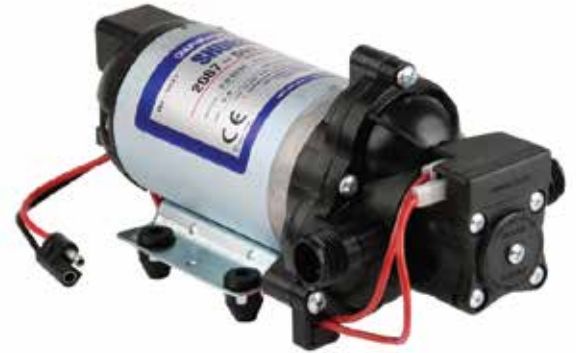
1. Check the water pump strainer to make sure it is not clogged. The strainer is located on the inlet side of the water pump and is meant to keep contaminants from entering the pump and causing damage. Remove the inline strainer filter and remove any debris that may have accumulated. Reinstall the strainer filter after it has been cleaned. If the pressure is still low, the pump may be weak or damaged.
